DYNAMIC SCIENCE, INC.
In-Depth Accident Investigation

Contract DTNH22-94-D-27058
Case DSI-95-AB-25

1. Report No. DSI-95-AB-25	2. Government Accession No.	3. Recipient Catalog No.	
4. Title and Subtitle In-Depth Accident Investigation		5. Report Date 1996

14. Sponsoring Agency Code	
15. Supplemental Notes This air bag investigation involving 3-month old female, right front occupant, in a rear facing child seat. The air bag struck the top rear of the child seat causing severe head trauma.

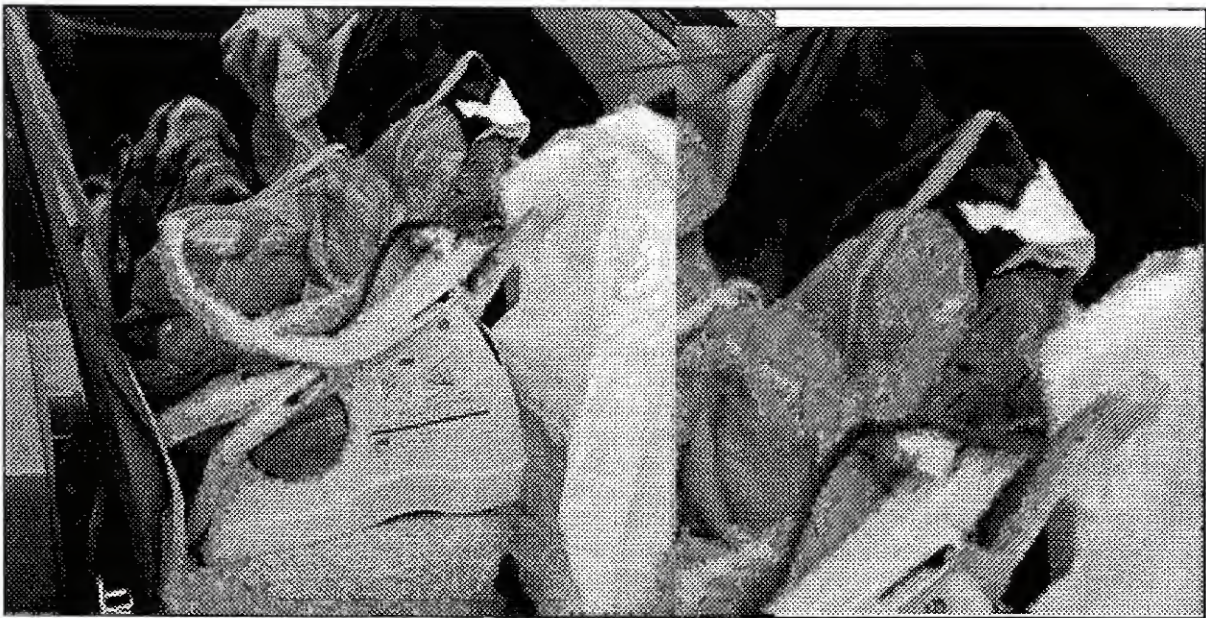
On impact with Vehicle 2, the air bag module cover struck the top rear of child seat and the top rear of the child seat shattered into many pieces (see Figure 2 and police photo # 047). At the same time, the air bag began its unfolding process, and contacted the rear area of the child seat causing rearward acceleration into the back head area of the child. The combined forces of the module cover striking the top rear of the child seat and the rearward acceleration by the deploying air bag, caused serious trauma to the child's head consisting of a right occipital fracture, a small subdural hematoma located in the right occipital area just below the fracture, a right occipital hematoma, all were caused by the back of the child seat. She also had an abrasion to the top of her forehead, a hematoma to her forehead, and an abrasion under her left eye. She was transported to a local hospital via ambulance, and she was hospitalized for eleven days. There is no other data available as to the exact nature of right front occupant's injuries, the mother did not want to cooperate with this investigation and the hospital would not release medical records without her authorization.

Figure 2. Police photo magnified to show damage to the top of the child seat, photo #114.

On impact with Vehicle 2, the air bag module cover struck the top rear of the child seat and it shattered into many pieces (see Figure 2 and Photo # 047). At the same time, the air bag began its unfolding process, and contacted the rear area of the child seat causing rearward acceleration into the back head area of the child. The combined forces of the module cover striking the top rear of the child seat and the rearward acceleration by the deploying air bag, caused serious trauma to the child's head.
